CORNER RECORD

BK 64 PG 70
Document Number CR 6866
County of ALAMEDA, California

Brief Legal Description CITY OF BERKELEY MONUMENT B3186

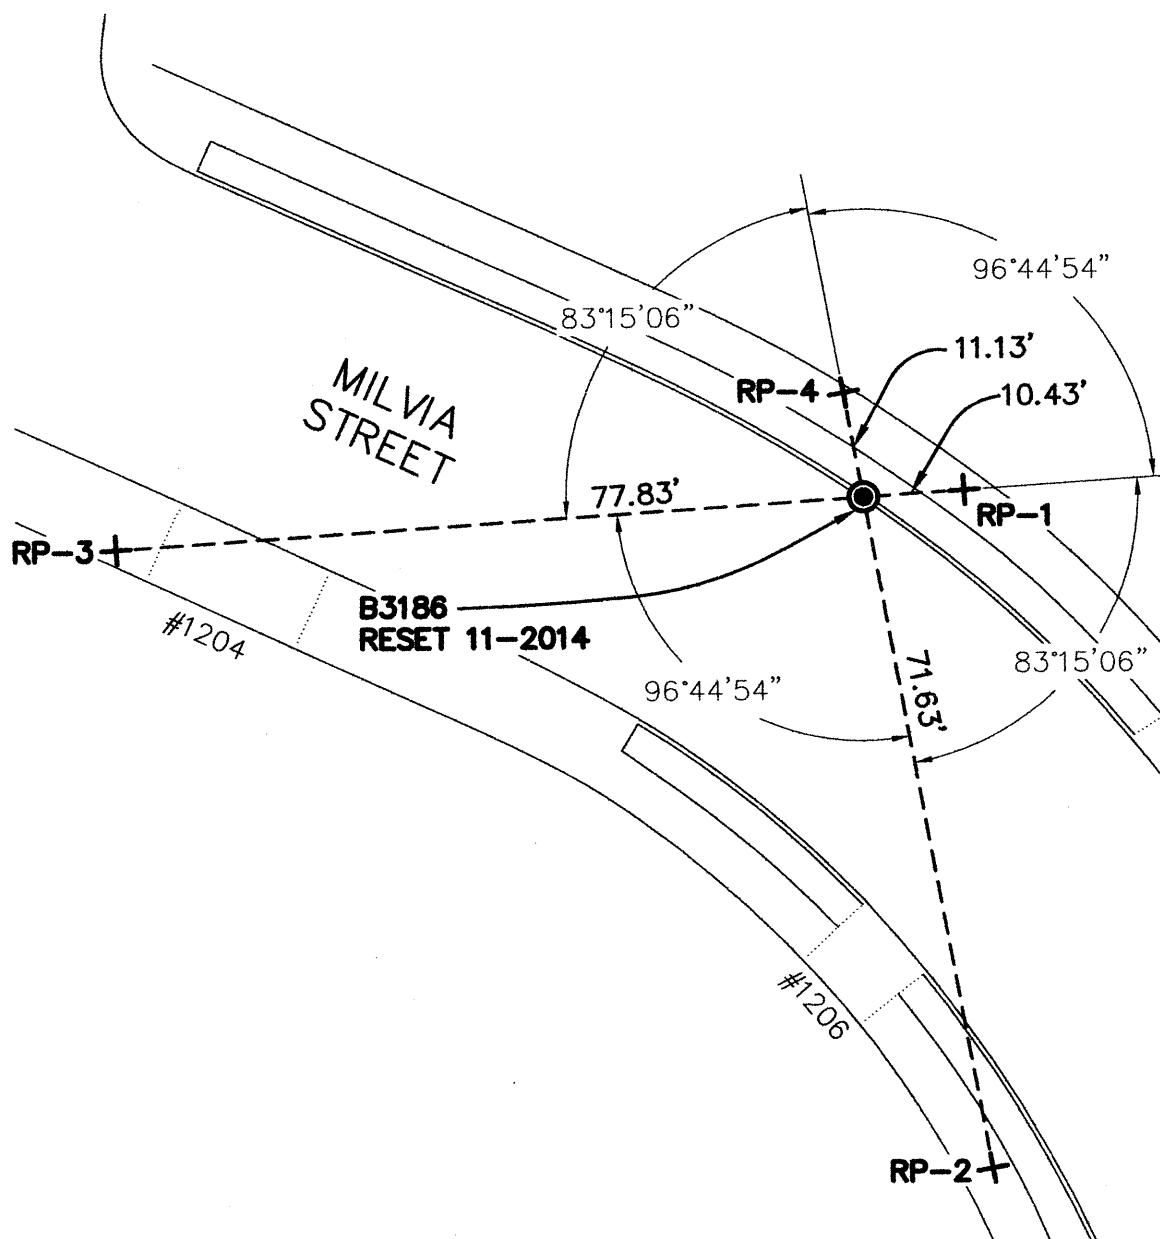
THE EXISTING MONUMENT AS SHOWN IS
REFERENCED BY STRAIGHT LINES BETWEEN
RP-1 TO RP-3 AND RP-2 TO RP-4.
